September 16, 2009

Regina Public Library – Central Branch **Interim Existing Facility Analysis**

P³ Architecture

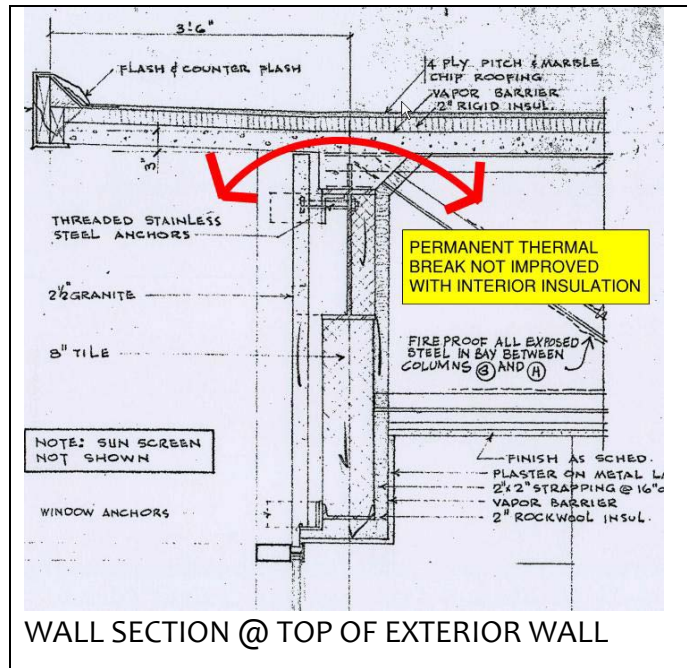
The sketch at right shows the thermal break that will remain if the exterior wall remains in place and additional insulation is provided at the inside of the wall only. The increased insulation on the inside of the wall will increase the potential for frost and condensation to form at the thermal break. i.e. on the inside surfaces of the thermal break.

Similar to the sketch above a thermal break at the floor line also occurs and would continue if the exterior walls are left in place.

The above noted insulation conditions can only be improved with the implementation of a cavity type wall on the exterior walls. Cavity walls are comprised of an exterior finish, a vented air space, insulation, air barrier and interior wall structure. The existing wall construction can not be retrofitted to a cavity wall without a complete dismantling of the wall and reconstructing a new wall.

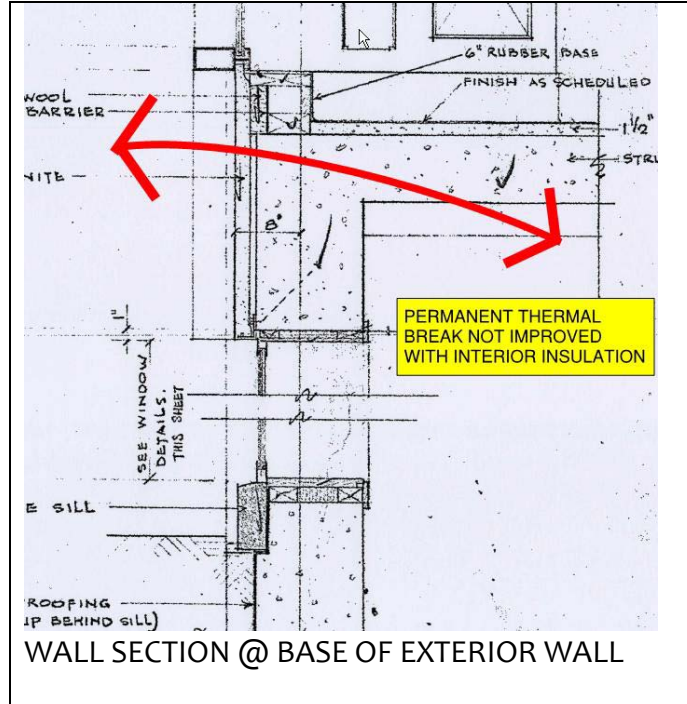
Another problem with the interior insulation renovation is the lack of a high quality air barrier. Interior insulation can only add a vapour barrier on the inside of the new insulation. A cavity wall system as described below is technically a far superior wall construction that incorporates a vapour barrier and an air barrier into one element that allows proper venting of the insulation space.
